THAMES RIVER BASIN
NORWICH, CONNECTICUT

BOG MEADOW RESERVOIR DAM
CT 00208

PHASE 1 INSPECTION REPORT
NATIONAL DAM INSPECTION PROGRAM

MAY 1979

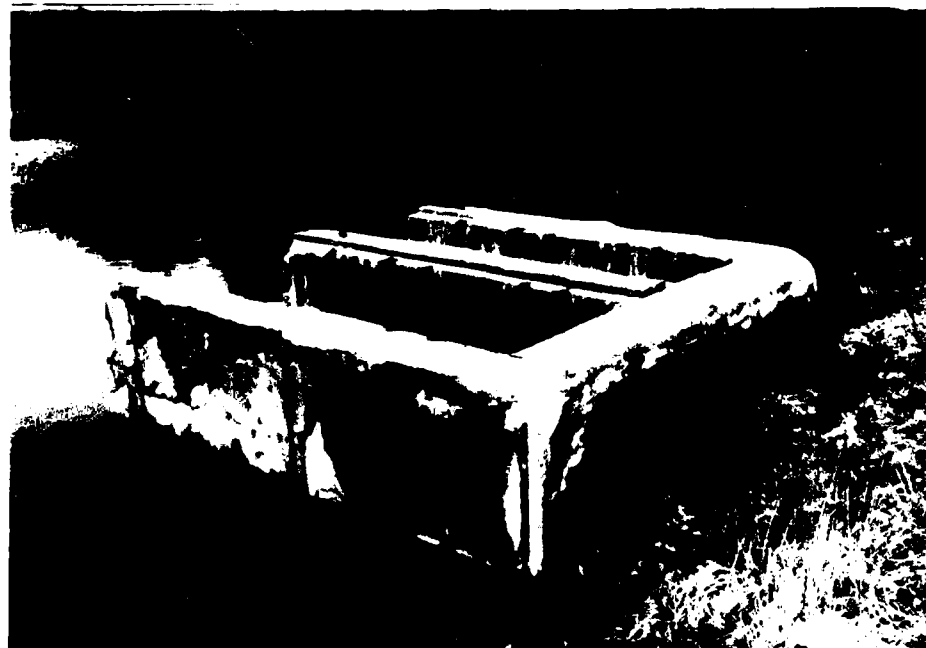
- c. Appurtenant Structures. The intake structure for the outlet works was constructed of reinforced concrete. This structure has some evidence of spalling but generally was in fair condition. No screens were observed at the intakes and were presumed to be either in storage or missing. No debris was observed obstructing the bays of this structure. (See Photo C-8).

C-8 INTAKE STRUCTURE FOR OUTLET WORKS.

3. The intake bays of the outlet works should be cleaned. Replace the screens and secure them from vandalism in order that withdrawals from the impoundment can be made without the potential for obstructions to the flow.

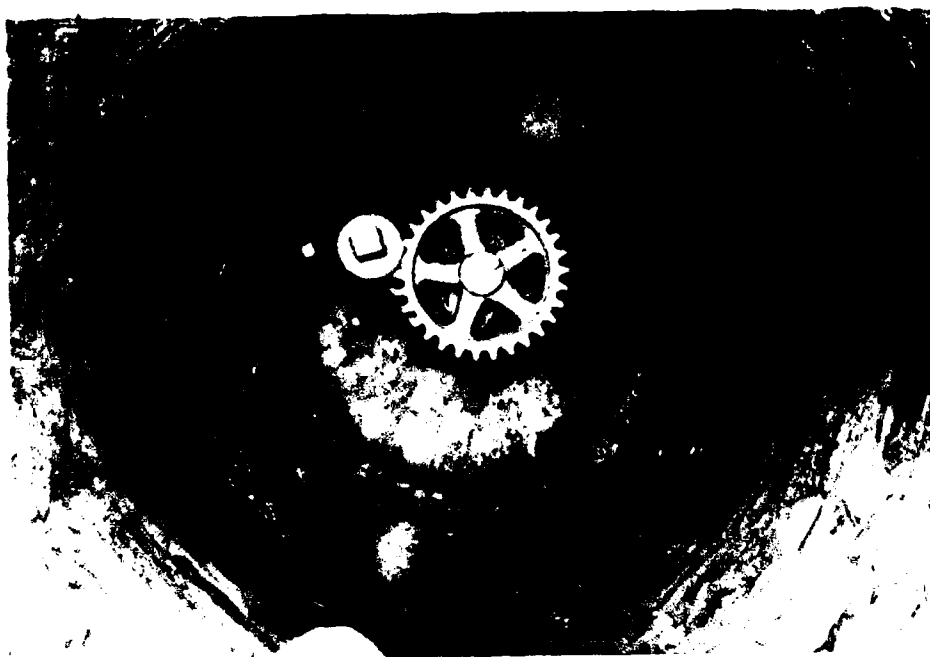
Below the dam a field stone masonry manhole on the 24 inch dia. cast iron conduit housed the control gate for the dam. The gate was not operated during the inspection but was reported to have been opened in the past year. The outlet conduit within the manhole was corroded. (See Photo C-9, 10).

C-9 CONTROL GATE TO DISCHARGE WATER BELOW DAM.

C-10 CONTROL GATE OUTLET.

- i. Planning for this facility should also consider relocating the control mechanism on the outlet works to the upstream side of the dam to eliminate a continuously pressurized pipe, the potential for pipe failure and internal erosion of the dam.
